**CANADICE LAKE DAM**

ONTARIO COUNTY, NEW YORK  
INVENTORY No. NY 443

**PHASE I INSPECTION REPORT  
NATIONAL DAM SAFETY PROGRAM**

NEW YORK DISTRICT CORPS OF ENGINEERS  
SEPTEMBER 1979

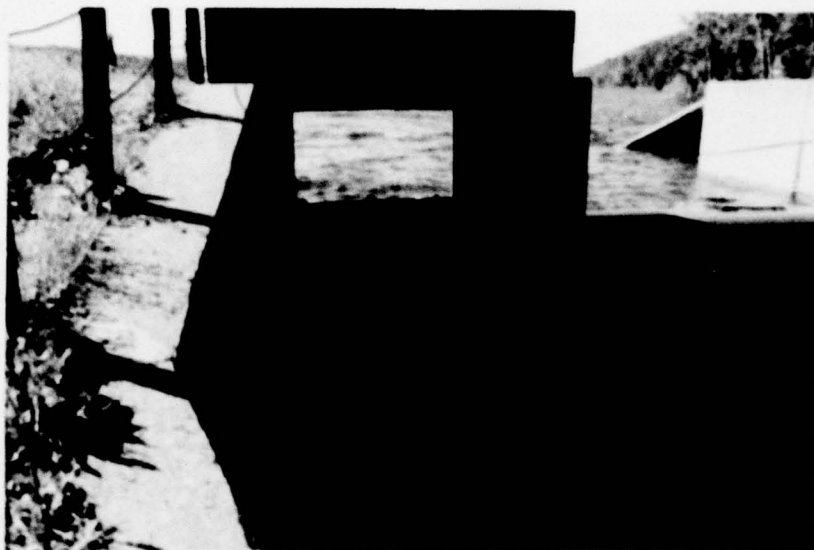
The principal spillway appeared to be in satisfactory condition. The sluice gate was well maintained and operational. Some minor spalling of the concrete at the entrance to the spillway was noted. There was a weir across the principal spillway exit channel to measure the flow.

Principal Spillway Sluice Gate

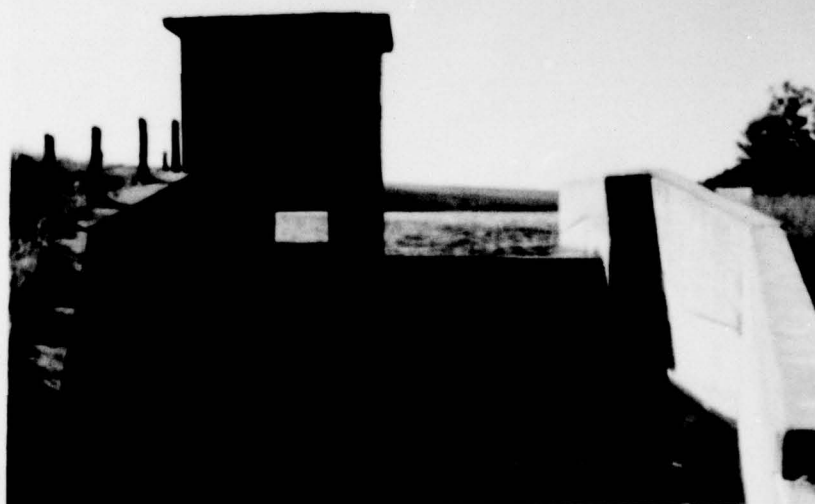
Principal Spillway and  
Adjacent Eastern Section of Auxiliary Spillway
